## STRUCTURAL, IMPACT & CYCLING TEST REPORT SUMMARY

**PRODUCT TYPE: Dual Action Inswing Side-Hinged Door**

**SERIES/ MODEL: "5000 Window/ Balcony Door"**

**NCTL-110-21258-1**

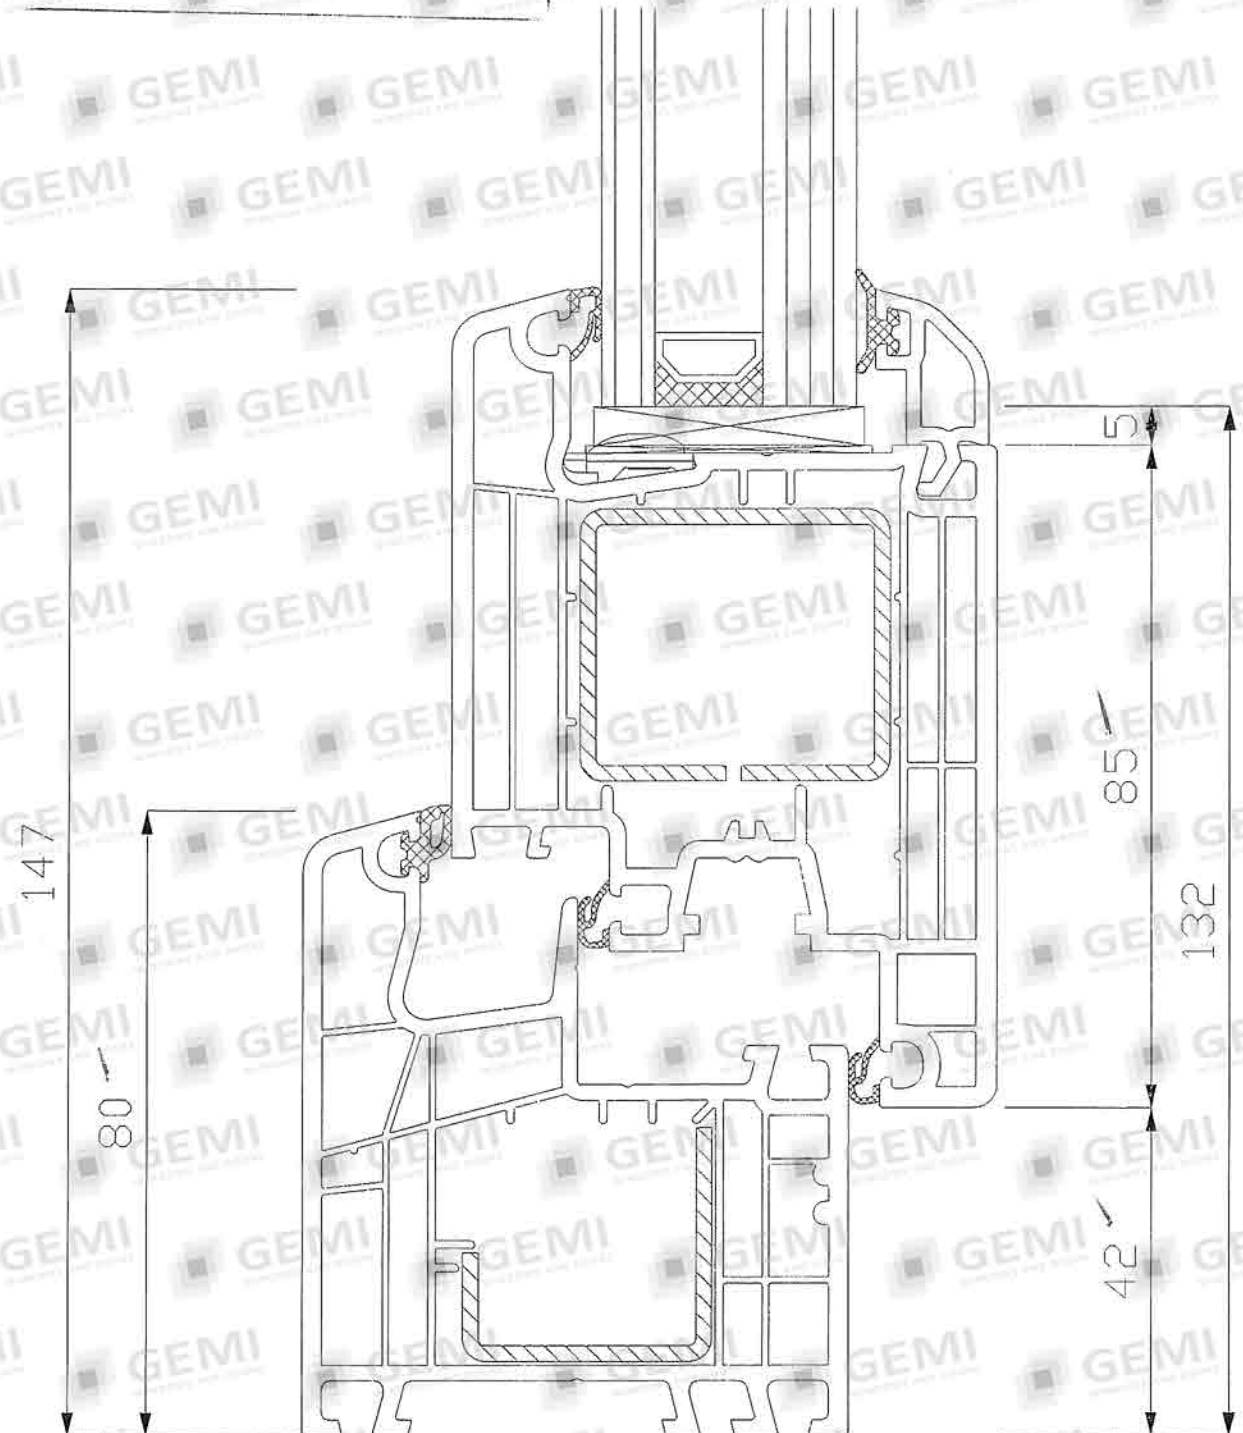
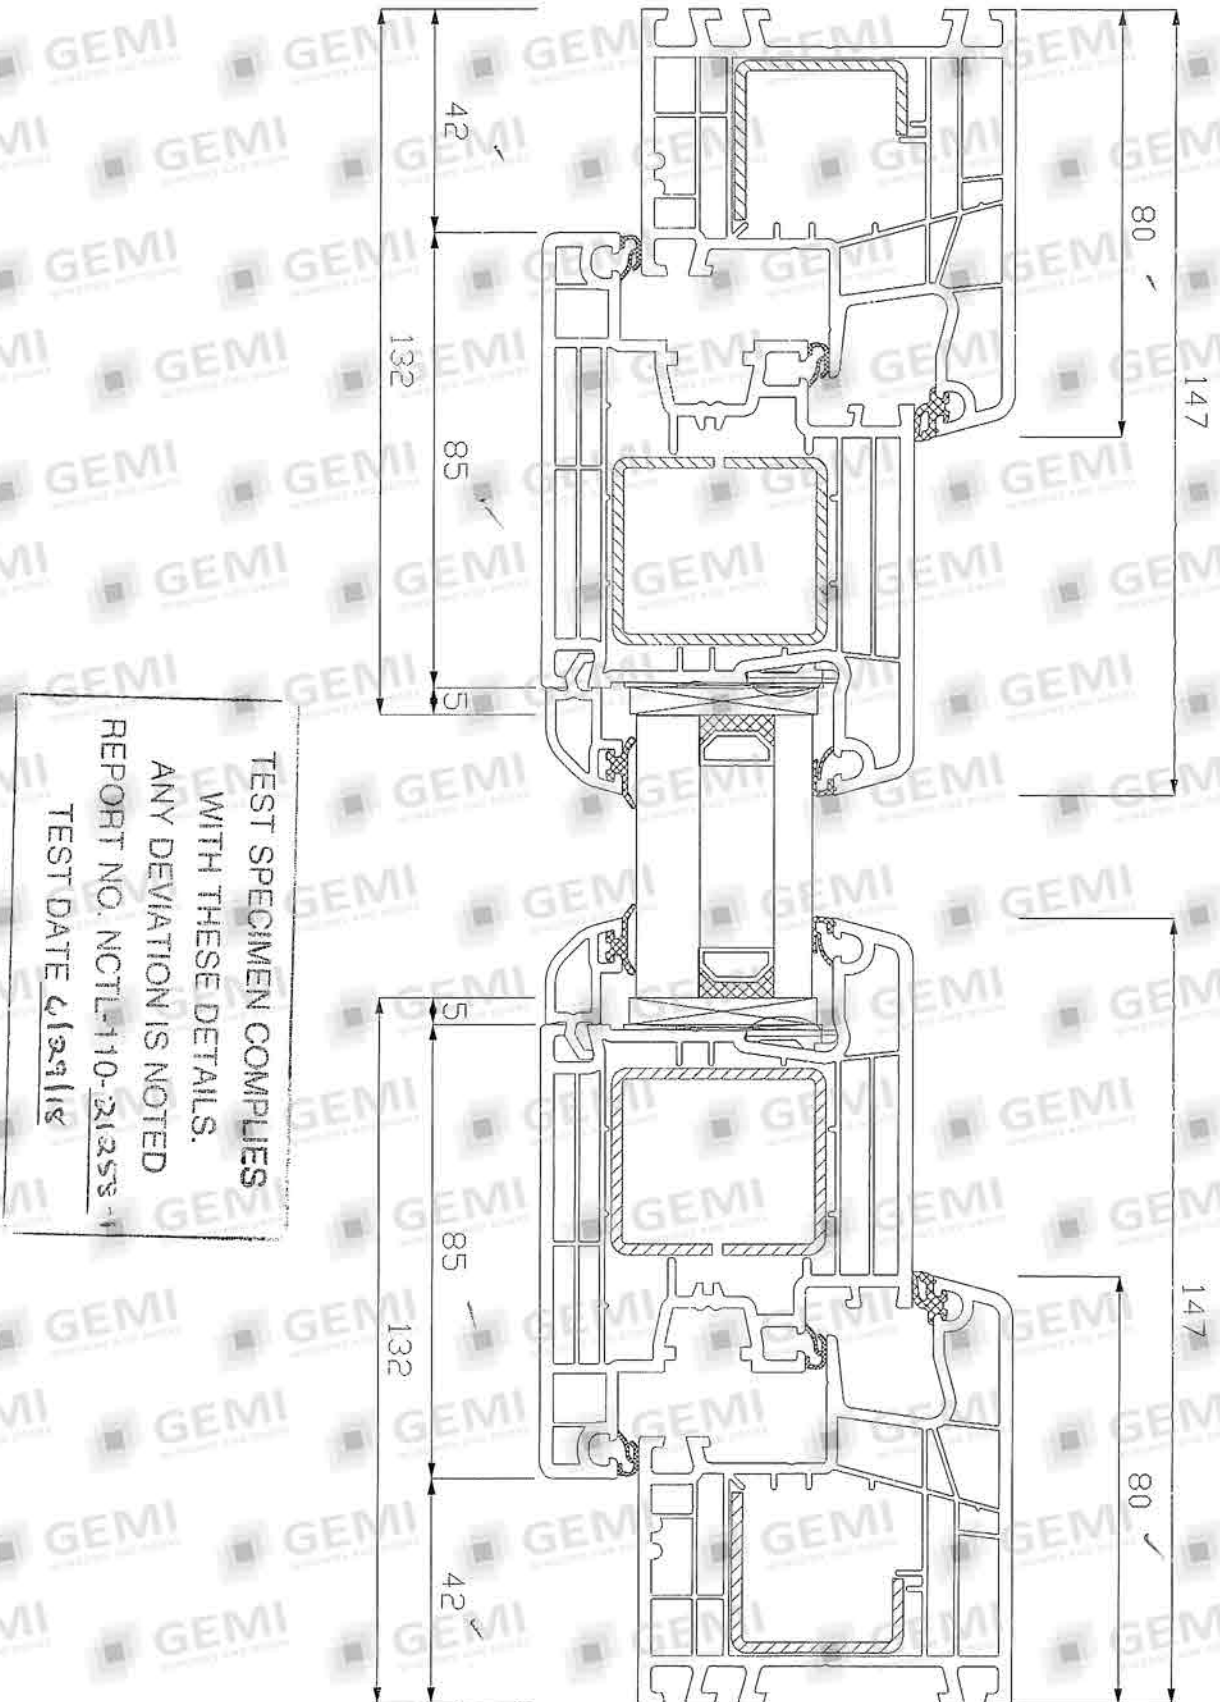
**Position BOM ID5000**

Profile system: aluplast IDEAL 5000®  
Rectangular window,  
Width: 1270 mm, Height: 2439 mm  
Field: 1 tilt & turn left

Glazing: Laminated VSG 33.2 – 14 – Laminated VSG 55.6

Frame profile: 80mm: 150x03, reinforcement: 239020 (Ix: 2.10 cm<sup>4</sup>, Iy: 1.10 cm<sup>4</sup>)  
gasket : EPDM

Sash profile: 105mm, Classic-line, recessed: 150x30  
reinforcement: 229115 (Ix: 6.40 cm<sup>4</sup>, Iy: 5.00 cm<sup>4</sup>)  
gasket : TPE  
hardware: G-U tilt & turn

Glazing bead: 20mm high, 17mm wide,  
black gasket EPDM: 120651

TEST SPECIMEN COMPLIES  
WITH THESE DETAILS.  
ANY DEVIATION IS NOTED  
REPORT NO. NCTL-110- 21258-1  
TEST DATE 6/29/18
